Manhole Inspection Summary

Manhole # S47U1_005MH

Location Address: **3101 Frankfurst Ave.**

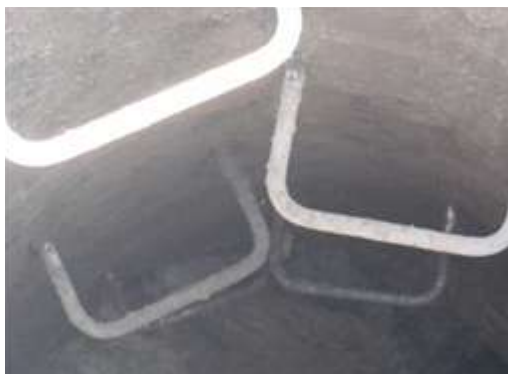
Steps

Count: **5** Missing: **0** ☐ Corroded

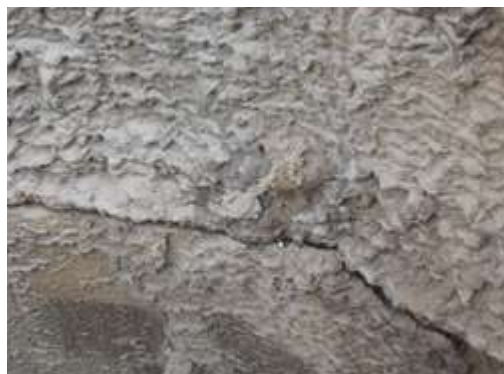
Defect 1

Condition: ☐ Sound ☒ **Cracked** ☐ Root Intrusion ☐ Loose Brick ☐ Deteriorated

Infiltration: ☐ None ☒ **Joint** ☐ Cracks ☐ Mortar ☐ Roots ☐ Wall

Crcked Frame-Chimney Joint.

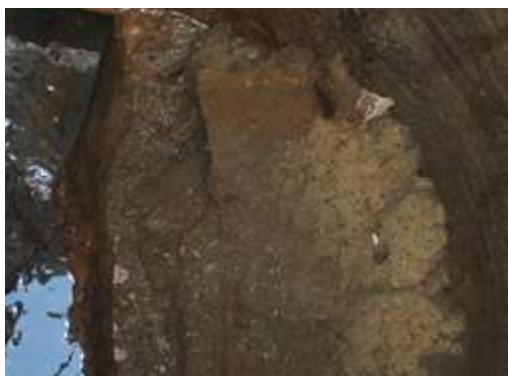
Defect 2

Condition: ☐ Sound ☐ Cracked ☐ Root Intrusion ☐ Deteriorated ☐ Leaks ☒ **Debris**

Debris on the bench.

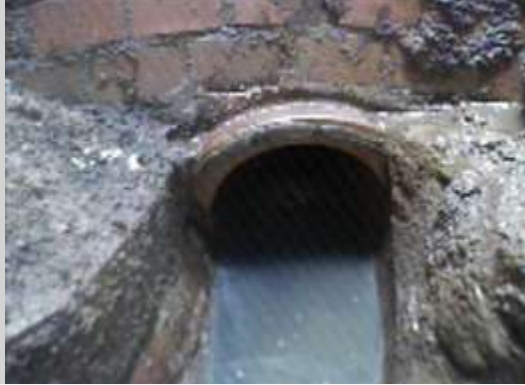
12 O'Clock Outflow

8 in. Circular Gravity Sewer
Pipe Out @ 12 O'Clock

Pipe Height: **8.4** (in.) Rod and Bar (Angled)
Pipe Material: **Clay** ☐ Pipe Lined
Invert Depth: **9.80** (ft.) Flow Characteristics: **Fast**
Deposits: ☒ None ☐ Mud ☐ ~~Gravy~~ ☐ Debris ☐ Grease
Silt Depth: (in.) Deposits Extent:
Infiltration: **None** Pipe Seal Cond: **Sound**

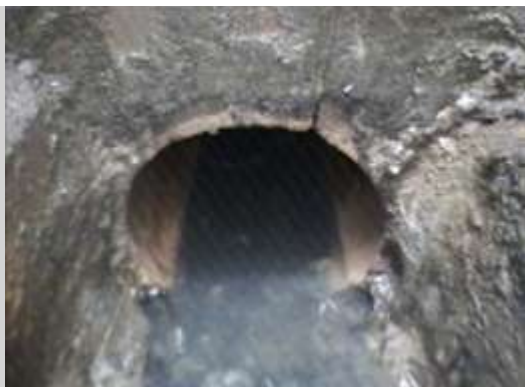
6 O'Clock Inflow

8 in. Circular Gravity Sewer
Pipe In @ 6 O'Clock

Pipe Height: **7.2** (in.) Rod and Bar (Angled)
Pipe Material: **Clay** ☐ Pipe Lined
Invert Depth: **9.68** (ft.) Flow Characteristics: **Fast**
Deposits: ☒ None ☐ Mud ☐ ~~Gravy~~ ☐ Debris ☐ Grease
Silt Depth: (in.) Deposits Extent:
Infiltration: **None** Pipe Seal Cond: **Cracked**

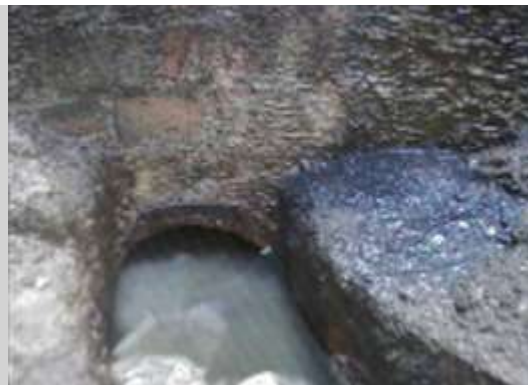
9 O'Clock Inflow

6 in. Circular Service Sewer
Pipe In @ 9 O'Clock

Deposits: ☐ None ☐ Mud ☒ **Sludge** ☐ Debris ☐ Grease

Silt Depth: **2** (in.) Deposits Extent: **Light**
